Osmotic Blister Repair Service

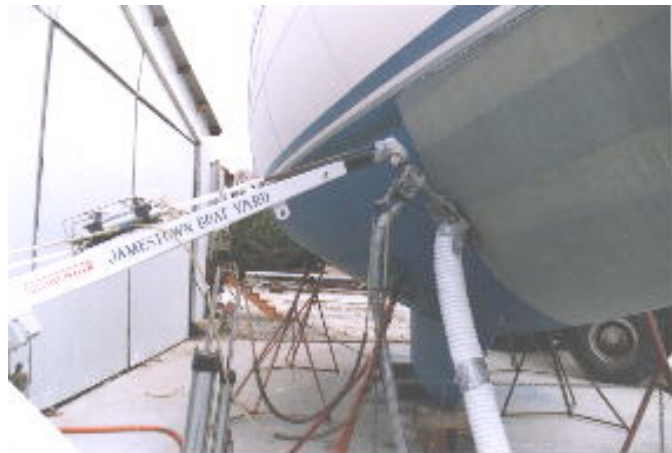
The boat is peeled, using our robotic gelcoat/laminate peeler, to a depth required to remove all damaged laminate and gelcoat. This is typically between 100-125 mils. The five-year warranted job will have one pass of our peeler around the hull. The ten-year

warranted job takes away more material and thus the peeler takes two “laps.” The boat is dried to 5% on the *A* scale of our Sovereign Moisture Meter. The drying takes place with infrared catalytic heaters and is a critical step in the proper repair of osmotic blisters. We have experimented with every conceivable way of drying hulls, including vacuum bagging, and found infrared heat to be superior.

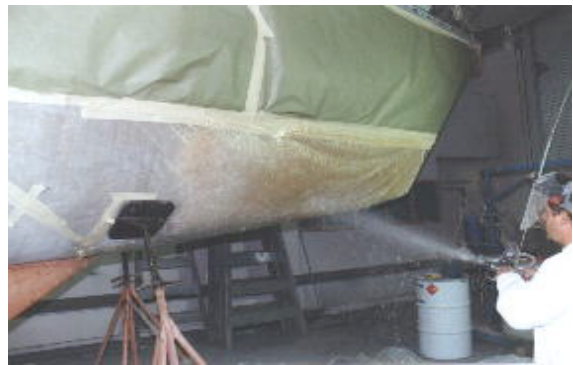
Once fair, the bottom is post cured; this is achieved by skirting the boat and applying temperatures in excess of 100°F for a period of 48 hours. We then spray International 2000 Interprotect to a minimum of 20 mils. The Interprotect is an epoxy barrier that has very high moisture barrier properties. An epoxy barrier is required to assure a good bond of the antifoulant to the LVVE fairing. The Interprotect, not only assures good bonding, but also has the advantage of superior moisture barriers and thus is the ideal product. The application of epoxies over the vinylester products is the reason we are required to post cure the LVVE. It is important to remember that the LVVE is our true barrier coat, the Interprotect is a tie-coat with additional barrier properties.
